Investigation of Frequent Failure of Francis Hydraulic Turbine Guide-Vane Shear Pin of Shiroro Hydro-Electric Power Station

M. A. Bawa^{a*}, A. Tokan^b and I. Salisu^c

^c Shiroro Hydro-Electric Power Generation Station, Kainji, Nigeria.

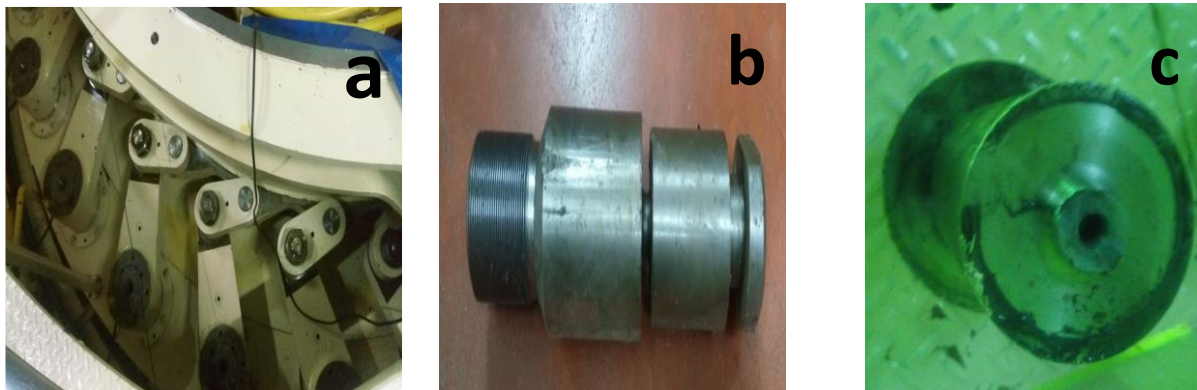
Figure 1: (a) Arrangement of Shear Pin with Turbine Regulatory Ring, (b) Shear Pin and (c) Fractured Shear Pin

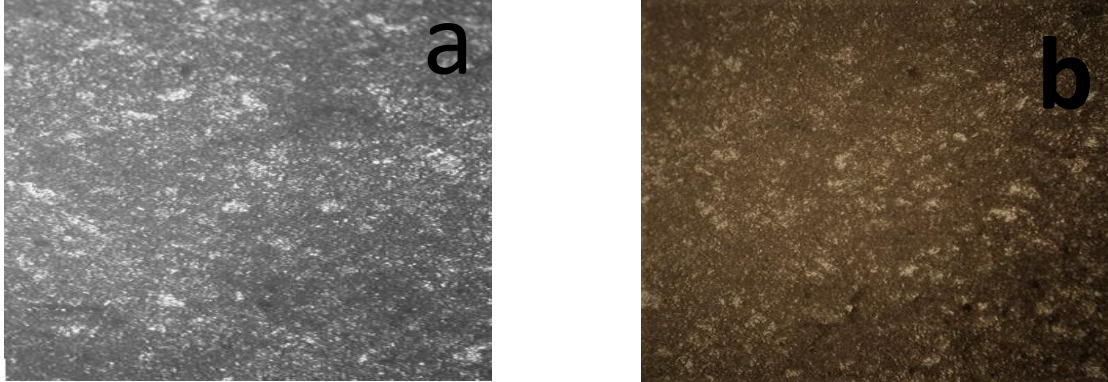
Metallographic examinations on some selected failed shear pins shows uniformity and close resemblance in their microstructures that are hardly distinguishable as shown in Figure 3. This inferred that the frequent failure of the shear pins could not have been due to discontinuity or segregations in the phases. The microstructure revealed dispassion of ferrite, retained austenite and traces of tempered martensite. The results indicated that the shear pin material was tempered after the preliminary manufacturing stage to impart some properties that will ensure durability of the pins as specified in the requirements for the shear pin production.

Figure 3: Microstructure of Two Samples of Shear Pin Material Showing (a) Ferrite and (b) Tempered Martensite Structure

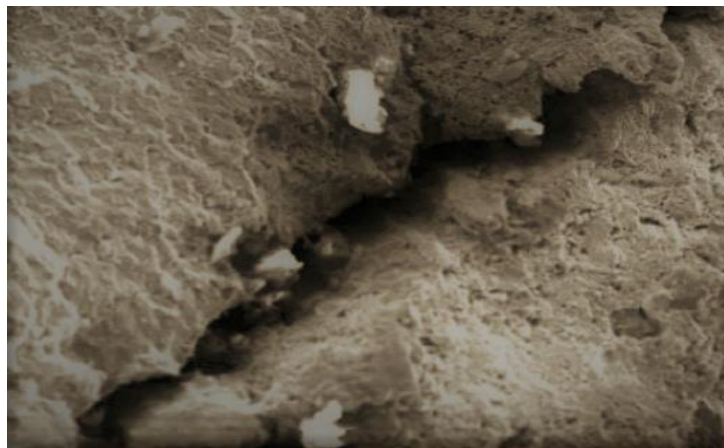
Figures 4 and 5 shows the result of fractography of the failed shear pin of the Shiroro hydro-electric power station done with 25kV accelerating voltage applied for the SEM analysis. From the figure, Micro cracks and oxide

particles were seen on the surface of the fractured shear pin which could most likely be due to overload or low cyclic fatigue phenomenon likely to be caused by the station's operating condition with frequent load rejection that causes water hammer or similar effects (Suresh, 1998; Blazek, 2001; Schijve, 2001; Kumar et al., 2012; Shalak, 2019). Visual observation and the fractographic analysis showed that the fracture was initiated on machining marks along the surface of the shear pin near the neck.

Figure 4: Result of Fractography of a failed shear pin taken with 25 kv @ X200 magnification factor

It is therefore recommended that frequent failure of the shear pins of Shiroro Hydro-Electric Power Station could be avoided or drastically reduced by adopting the following;

- i) Adopting spinning reserve system not free governor system for operating Francis Hydraulic turbine.
- ii) Improving the transmission and distribution network so that the power generated can be evacuated without rejection.
- iii) Further analysis on the shear pin frequent failure be carried out based on design and applied forces.
- iv) Analysis of pressure effects at different points in the penstock, wave speed of water hammer and guide-vane closing time (wicket gate) be carried out to mitigate the effect of water hammer.

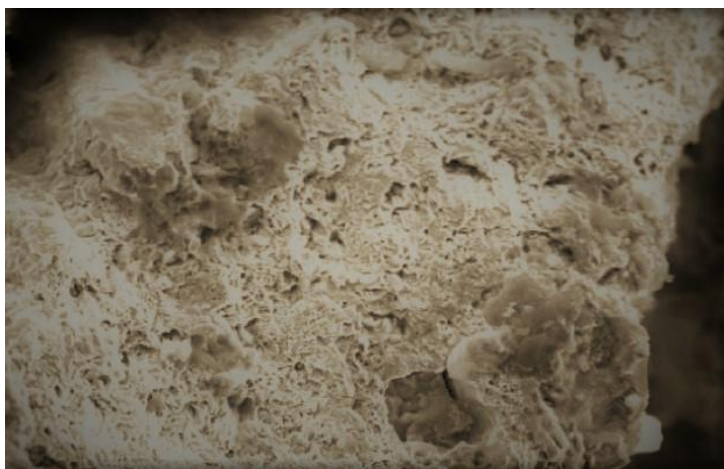
Figure 5: SEM at 25 kv Fractograph at the Neck Portion Showing Brittle Fracture at X200 Magnification Factor
