# **The Effects of Water Erosion on The Eastern Bank of the White Nile at Detang Village in Upper Nile State, South Sudan.**

By: Okel Akol Ajawin I, College of Education, Upper Nile University-Upper Nile State, Malakal  
Supervisor: Dr. Alamin Alawad Hag Ahmed, Faculty of Urban Sciences, AlZaim Alhari University-Khartoum-Sudan  
E-mail: Elaminhag1@gmail.com  
Tel: 0912484650  
Correspondent Author: Okel Akol Ajawim  
E-mail Address: Okelakol77@gmail.com  
Telephone No. 0961512013

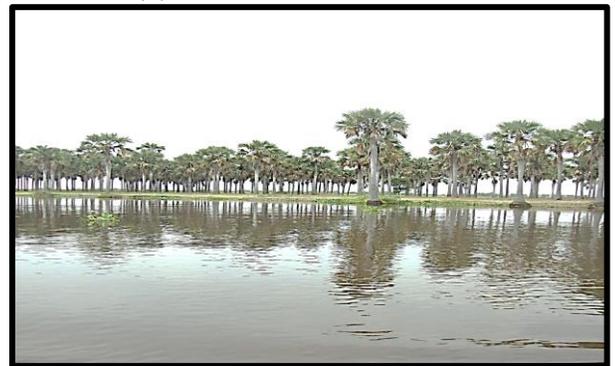
Plate No. (1)

- The expanding of the eastern bank of the village towards the western side of the village at the expense of the land. stream, see plate No. (1)

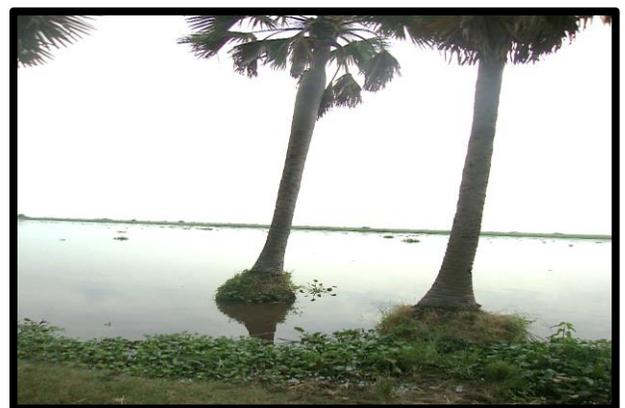
Plate No. (2)

- The standing of some plane trees – *Borassus-aethiopicum* in the area of shallow water of the White Nile than on the land in the previous years. stream, see plate No. (2)

- i-The spreading of White's Nile water into the area of plane trees (Dolieb) Borasusaethiopum.
- Standing of Borasusaethiopum on the area of shallow water of the White Nile.

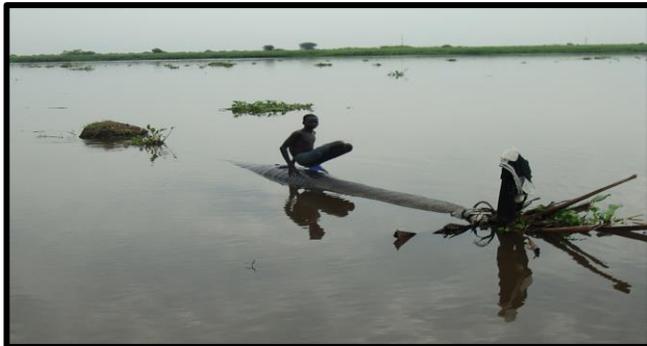
- The small distance between the residential areas and the channel (stream) of the White Nile
- Failing of the–Borasus-aethiopum into the White Nile stream,see plate No.(3)
- Plate No. (3)

- The detachment and removal of soil materials from the land and around the roots of trees.
- Failing of Dolieb trees Borasusaethiopum and slumping of the bank into the flowing water of

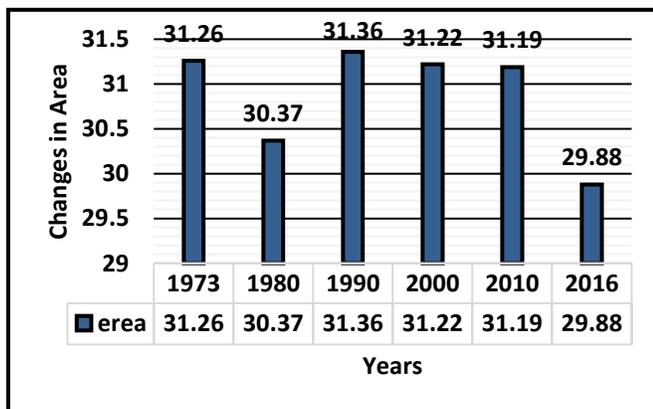
- The general changes (in kilometers squares) on the study area during the period 1973 -2016.

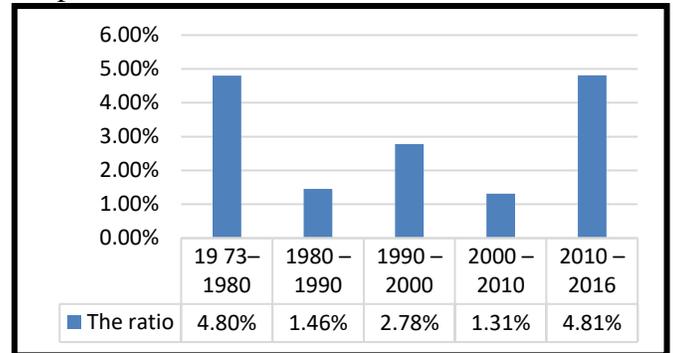
Chart (2) The Ratio of the Affected Areas during the period 1973-2016

- The ratio of the affected area (in percentage) during the period 1973-2016 sees chart No. (2).

year but can be observed cover time. Therefore, the worth-mentioning findings of those analysis, is the fluctuation and variation in the size of the affected area (in percentage), and the amount of changes (in kilometers squares) in the study area during the period of 1973 and 2016. Accordingly, the amount a change in the Island between the period 1973 was estimated at 31.26 kilometers square (km<sup>2</sup>), where the affected area by water erosion was 4.80% of the total area of the Island. Even though, the amount of change decreased in 2016, estimated at 29.88km<sup>2</sup>, the percentage of the affected in the same year, showed a remarkable increase in the area amounted to 4.81%.

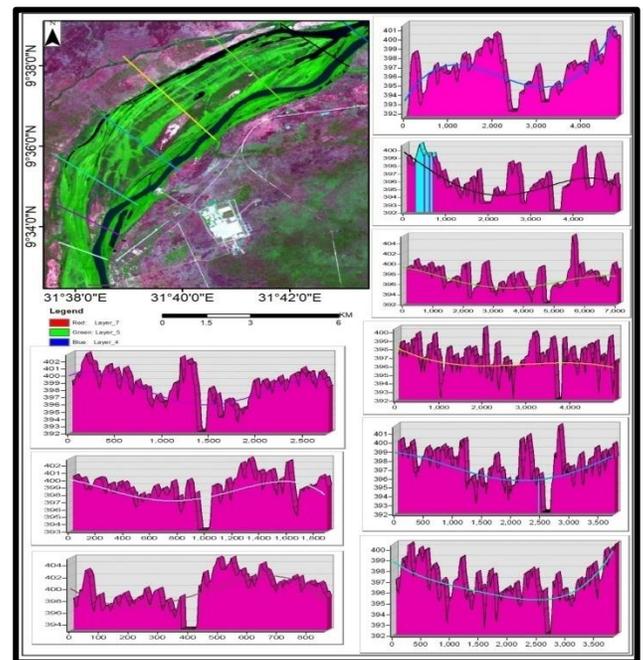
- The contour map of the study are
- The Cross-Section of the Study Area ,see Graph No.(1)

Source: By the Researcher According to Land sat image, thematic mapper™, digital formed, 7 spectral bands path 173 and row 53, acquired 2010.

- The undulated surface of the study area, sloping northwards in accordance to the general slope of the continent, where the study area (Detang) village appeared in the cross - section as a concave slope. This would cause an increase in the slope length that increases the surface area for water collection. On the other land, the western bank of the White Nile at Detang village appeared in the cross-section as a convex slope, which showed the increase in the degree of steepness, coupled with the existence of sandy loam soil in the area, this strengthens the surface run-off, loss of soil materials and nutrients, organic matter, calcium and seeds, moving them into the White Nile stream.

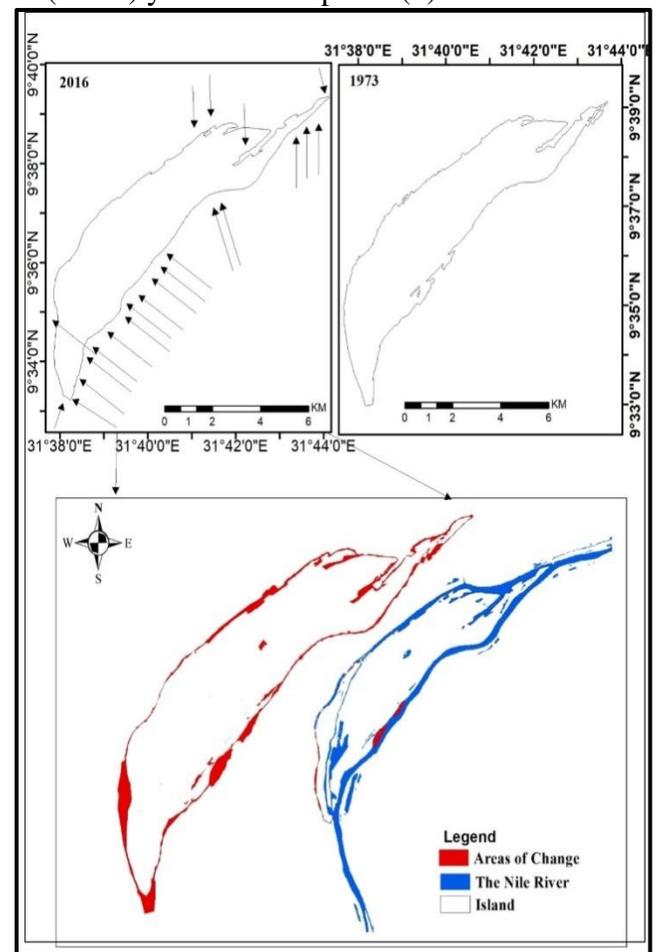
Between 1973 and 1980, the amount of change on the Island in this period was estimated at 1.46km<sup>2</sup> and by 4.80%. The effect of water erosion was clear in the South-eastern part of the Island, especially in the area where clay soil predominates in the area of dense plane trees. Borasus-aethiopum are standing in this part of the Island,

In the period between 1980 and 1990, the amount of change in the Island amounted to about 0.46km<sup>2</sup> and 1.46% where the effect of water erosion was slight along its eastern bank, starting from the south; the middle and the northern part

respectively. The period between 1990 and 2000, showed a remarkable increase in the process of ongoing erosion amounted to 0.87km<sup>2</sup> and by 2.87% of the total area of the Island, where the effect was on the south east and north – east of the eastern banks of the study area. The period from 2000 to 2010 was calculated at 0.41km<sup>2</sup> and by 1.31% of the total area of the Island. This is the period during which the water has been shown to play an active role in the process of erosion on the banks of the Island in general and the western bank of the White Nile at Detang village in particular area.

Finally, the period between 2010 and 2016, is the period in which the erosion strongly affected the Island for half a century, with a total impact on the concerned bank about 1.44km<sup>2</sup> of the total area. Base on the affected area within Period of (1973-2016) 43 years, the total percentage was (15.16%), which means that the entire island would disappear in (283.8) years see Map No. (2).

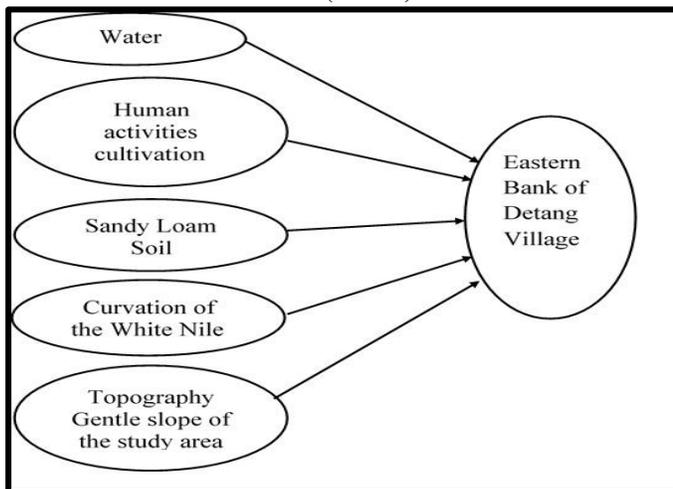
Chart (4): Independent Variable(Cause) and Dependent variable(Effect).

- The Curvation of the White Nile Channel within the study area.
- The Sandy Loam Soil
- The General Slope of the Study Area
- Human Activities
