THE GEO-ENVIRONMENTAL MENACE BY FLOODING AROUND IKWUANO AREA, SOUTHEASTERN NIGERIA

1. Uzoegbu, M. U. and 2. Agbo, C. C.

^{1,2} Department of Geology, College of Physical and Applied Sciences, Michael Okpara University of Agriculture, Umudike, PMB 7267, Umuahia, Abia State.

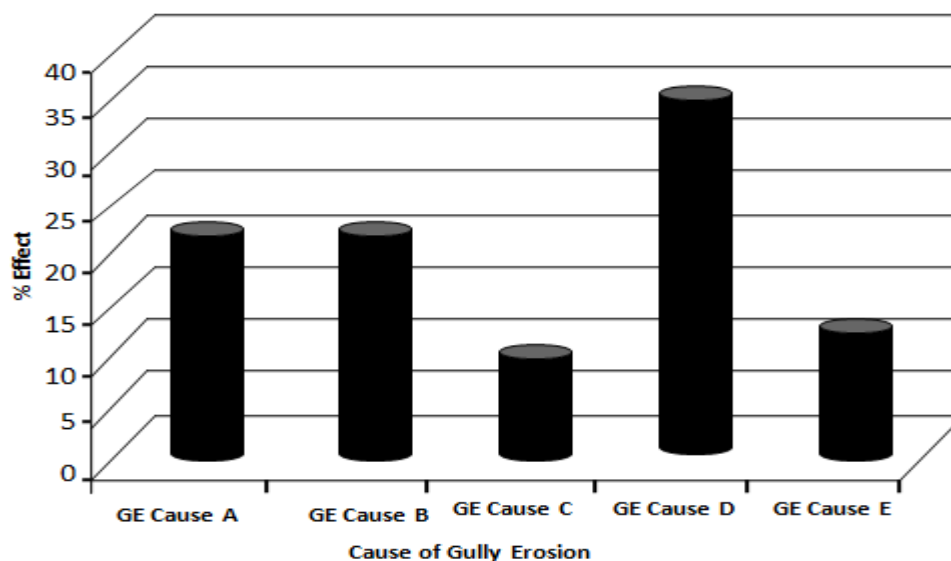
Fig. 3: Percentage effect of the causes of Gully erosion in Ikwuano LGA (After Onyelowe, 2017).

For the purpose of handling, the identified causes of gully erosion in Abia State were labeled GE-Cause A: lack of drain facilities, GE-Cause B: badly constructed road pavements, GE-Cause C: negligence to rainfall and runoff volume during the design stage of drains, GE-Cause D:

dumping of municipal solid waste on drain channels and GE-Cause E: wrongly located building structures as a result of wrong planning, (where GE is Gully Erosion) and the responses from the affected local governments in Abia state were evaluated in percentage (Onyelowe, 2017).

Fig. 3 also showed the gully erosion diagrammatical effects of the different identified causes A to E in Ikwuano Local Government Area of Abia State. It could be deduced that again GE-Cause D; dumping of municipal solid waste on drain facilities was predominant in effects. This also goes to show that this does not only deface the environment, but poses lots of geoenvironmental hazards ranging from pollution and emission of poisonous metal gases to the decay it causes on the transportation facilities on a daily basis. And this adversely affects the lives of the people (Onyelowe, 2017).

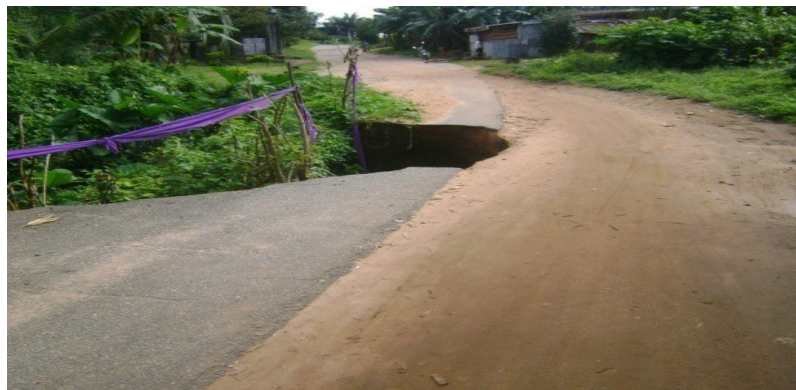
Picture 1: Failed portion of road site at Ndoro-Itunta (Elemaga-Ibere) road.

However some parts of the roads at the three sites (Numan town, New Demsa, Farei and Imbru failed probably because of poor work done during construction. The road at Dowaya site failed probably because the values of result exceed the British standard Institution (BS) and (AASHTO) recommended limits (Pictures 1 and 2).

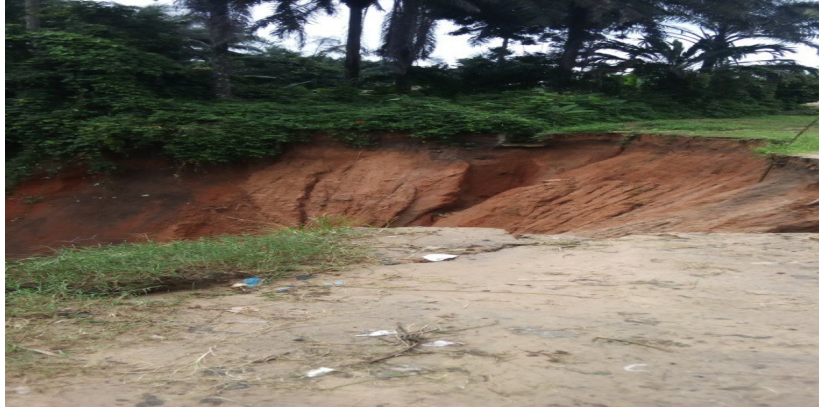
Picture 2: Failed portion of road site at Ariam-Usaka ring (Amaegbu-Ariam) road.
